Brief Analysis of Assertion of Pre-Existing Cement Pad Underlying Newly Asphalted Area at Jetport Site

July 8, 2025

Christopher McVoy, Ph.D.

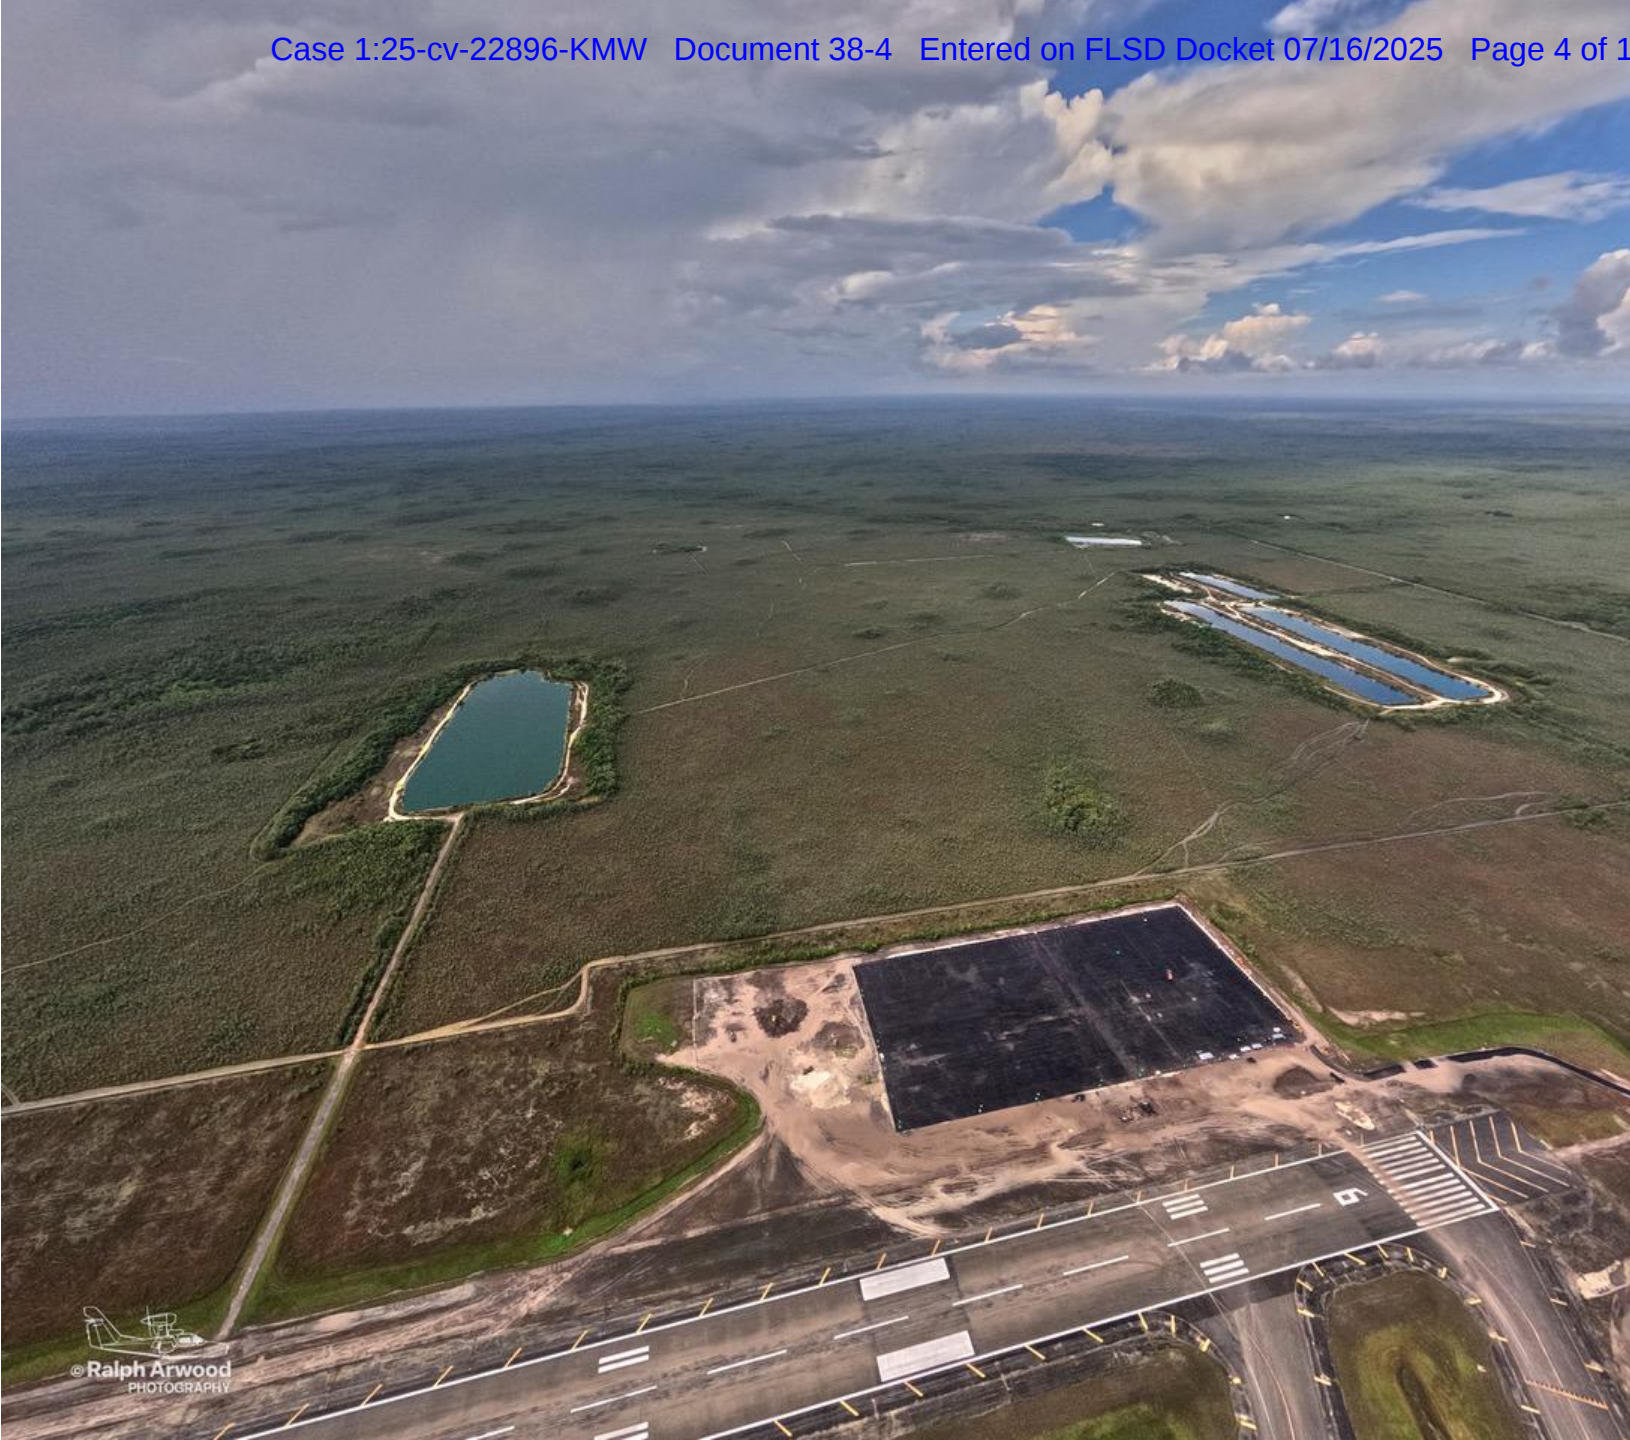
Photo 23,
Looking S.

Dark
rectangle
is new con-
struction
(asphalt
pad).

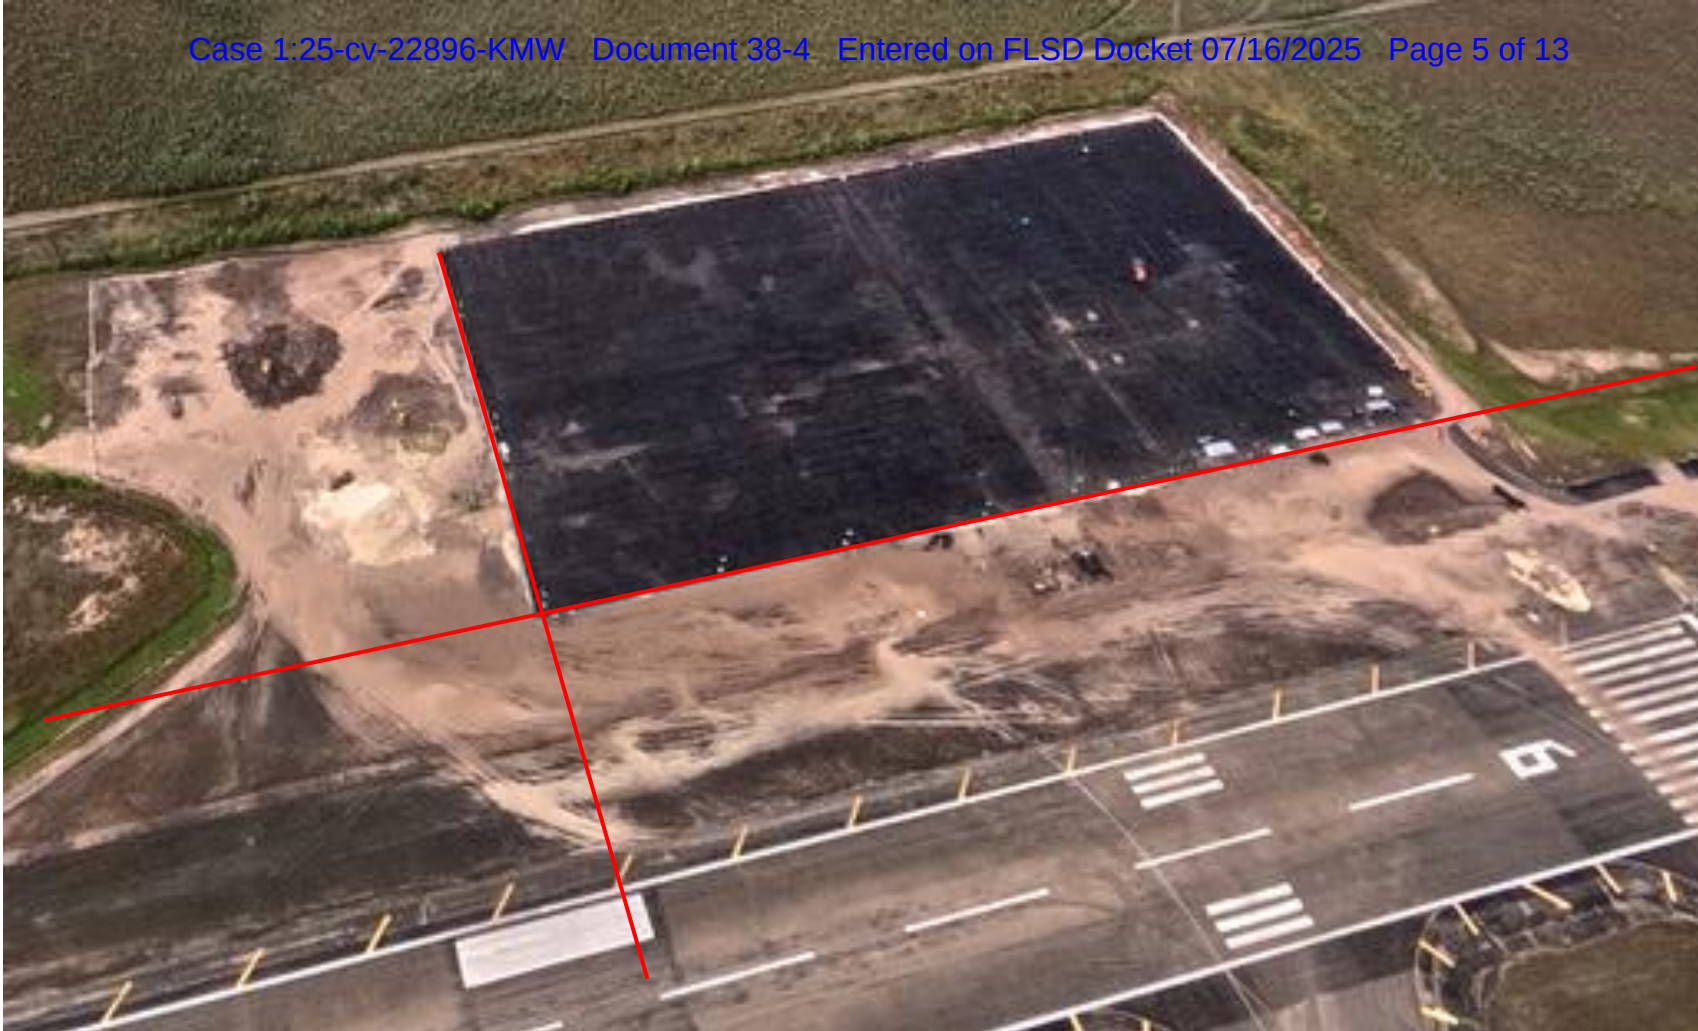
Detail of Photo 23. Dark rectangle is new construction (compare with June 2025 Google Earth satellite imagery). Dark is almost certainly asphalt paving. Light sandy brown area to east and north of asphalt is newly scrapped area. Red alignment lines were used to estimate extent of assumed paved area (next slide).

Note that the light sandy brown area (i.e., unasphalted area) gives no indication of being “a thin layer of dirt” on a pre-existing cement pad.

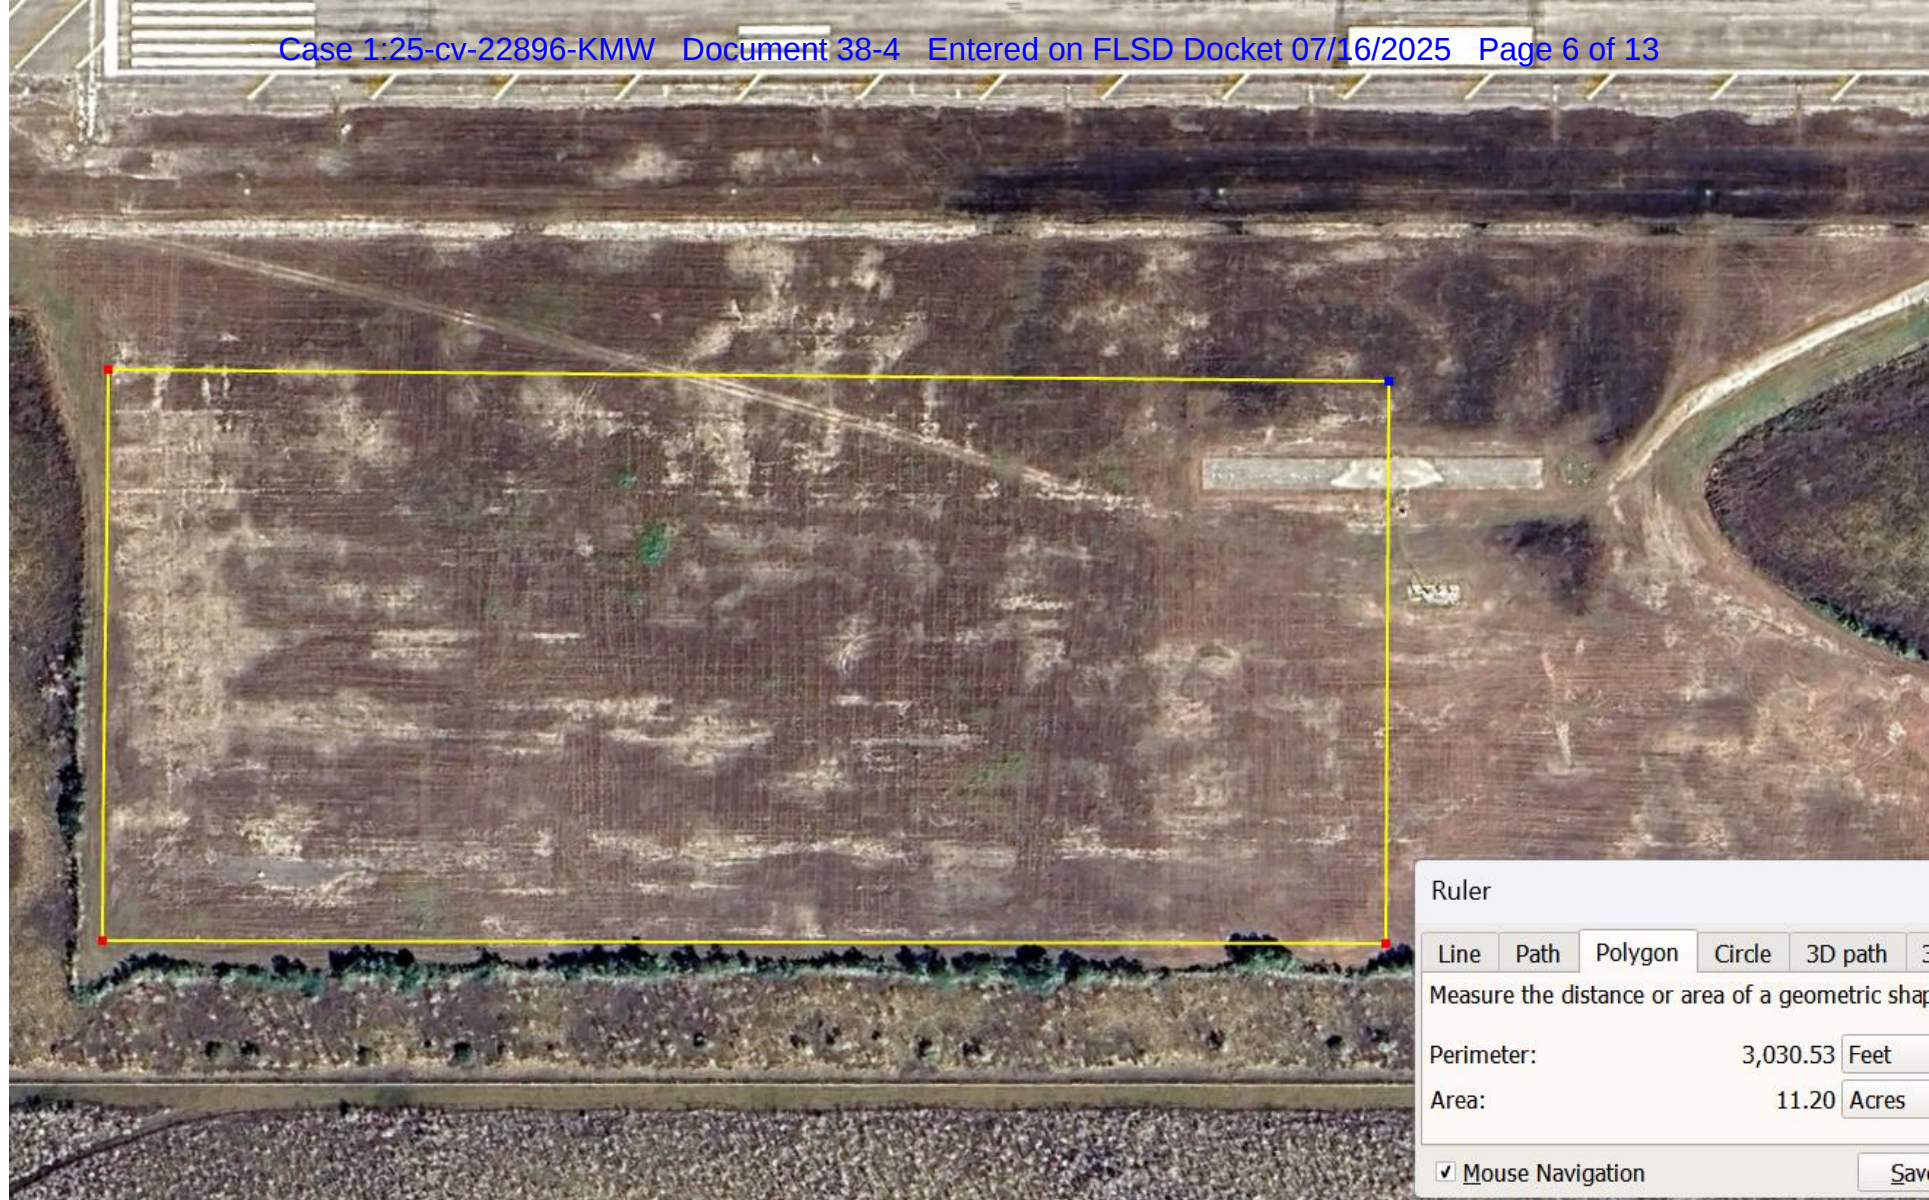
Untilted, unrotated Google Earth image used to estimate area of the paved region shown in Photo 23. Alignment lines shown in previous slide were used to locate eastern and northern boundaries; vegetation rows to estimate location of southern and western boundaries. This newly paved area estimated to be **11+ acres**.

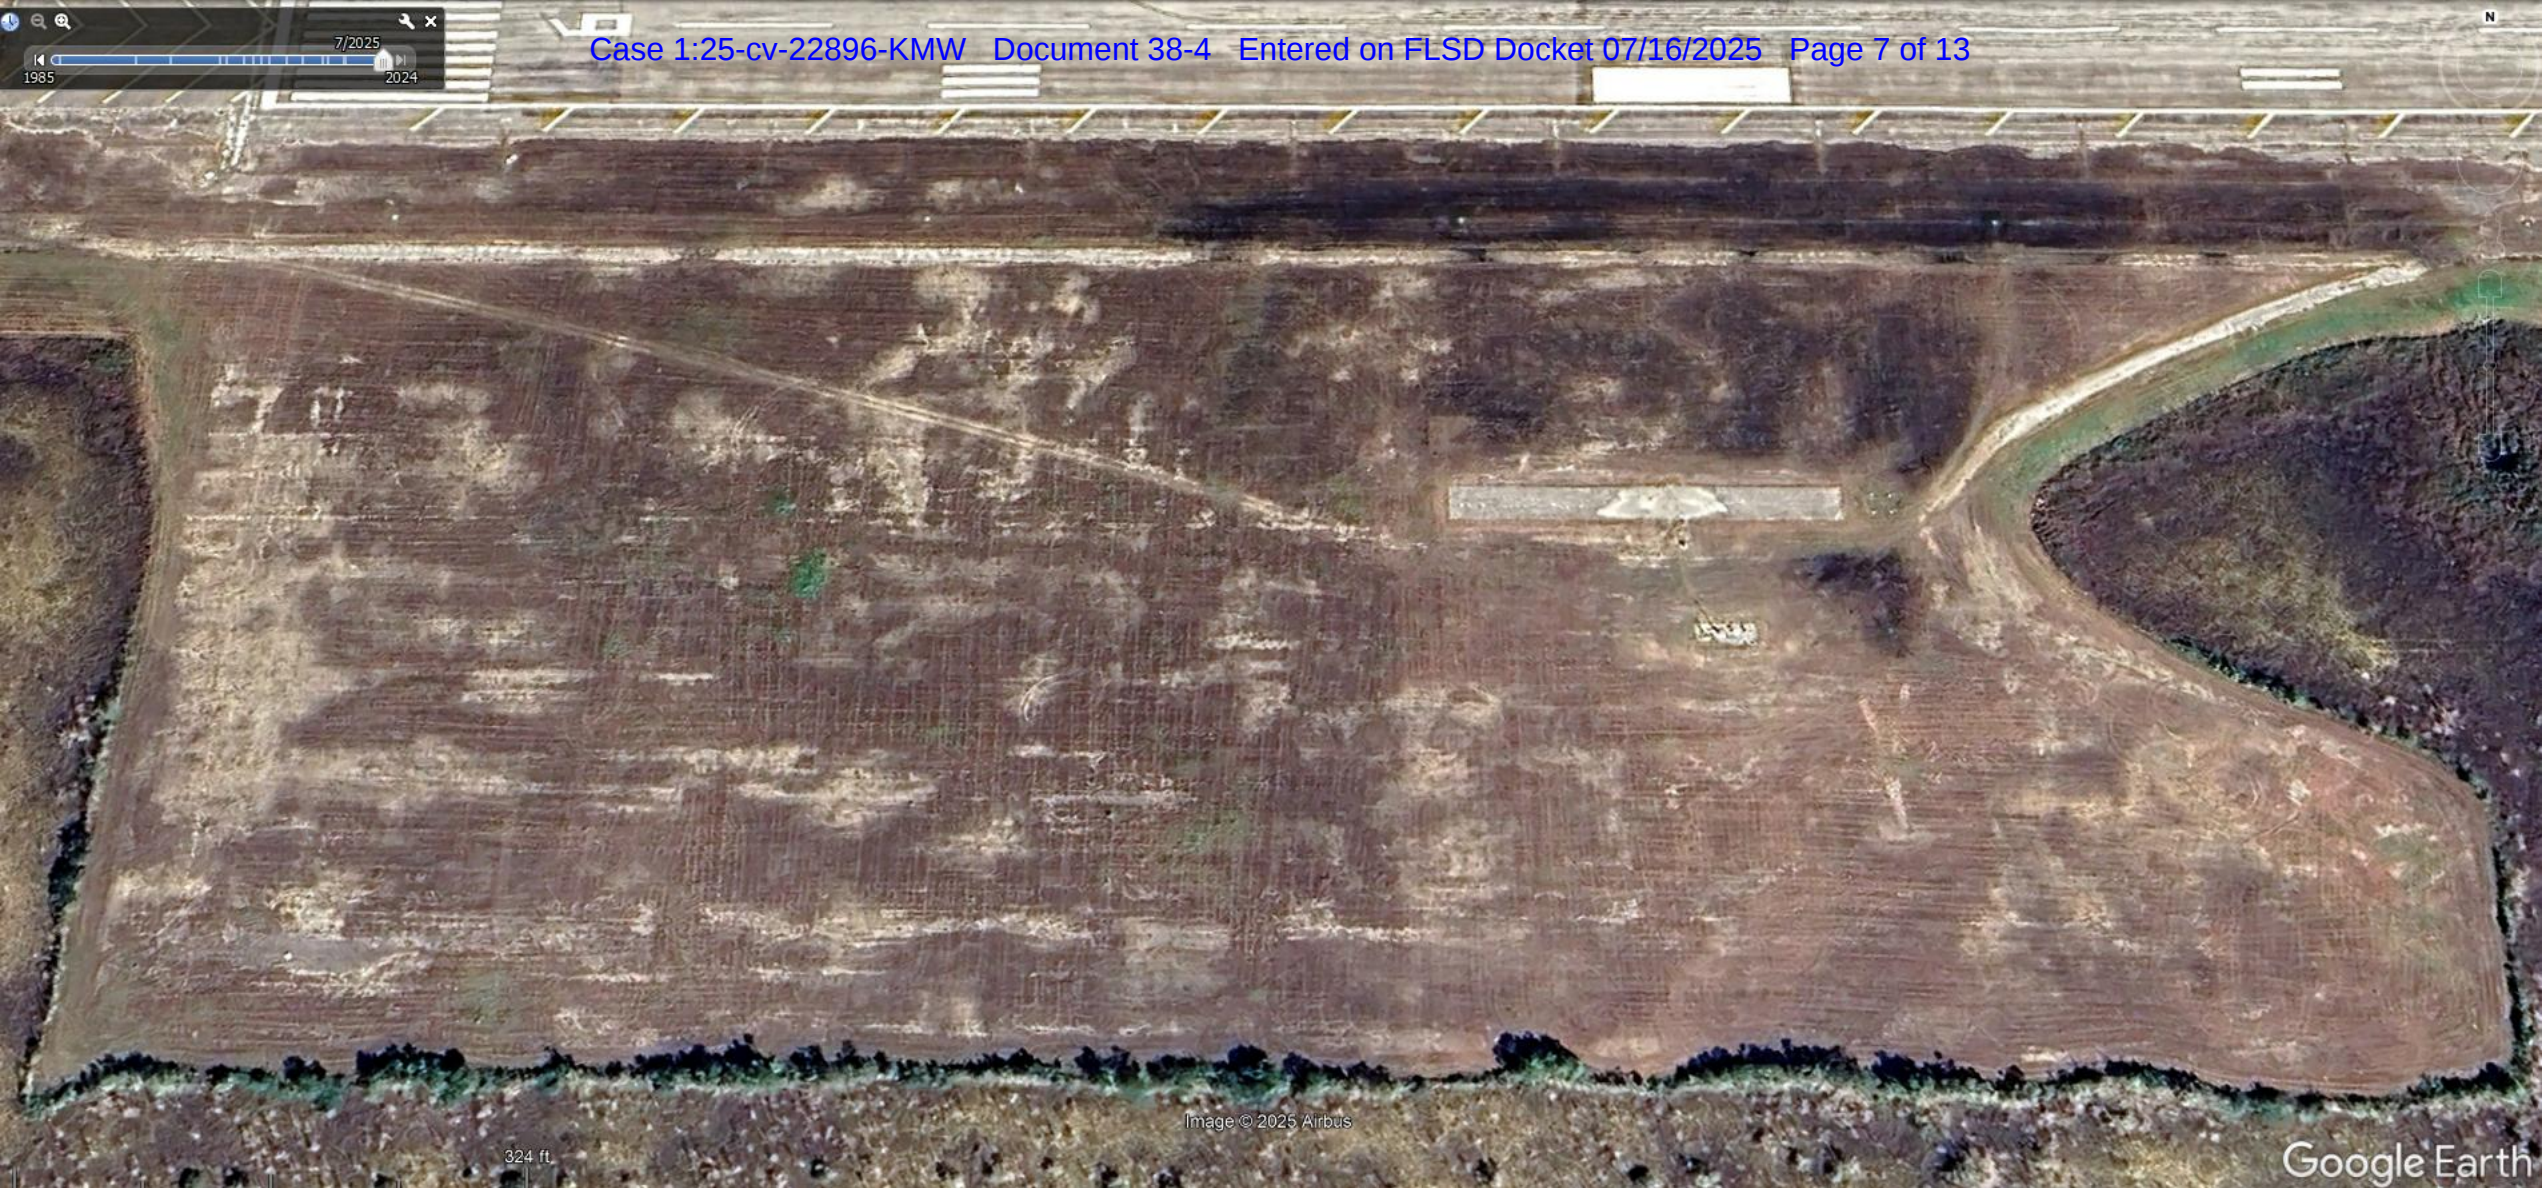
Google Earth Imagery, 2025 (prior to any detention center construction). Note the N-S and E-W patterning, which is likely from equipment such as mowers or brush hogs criss-crossing this area. Vegetation that needed mowing would not grow on top of cement.

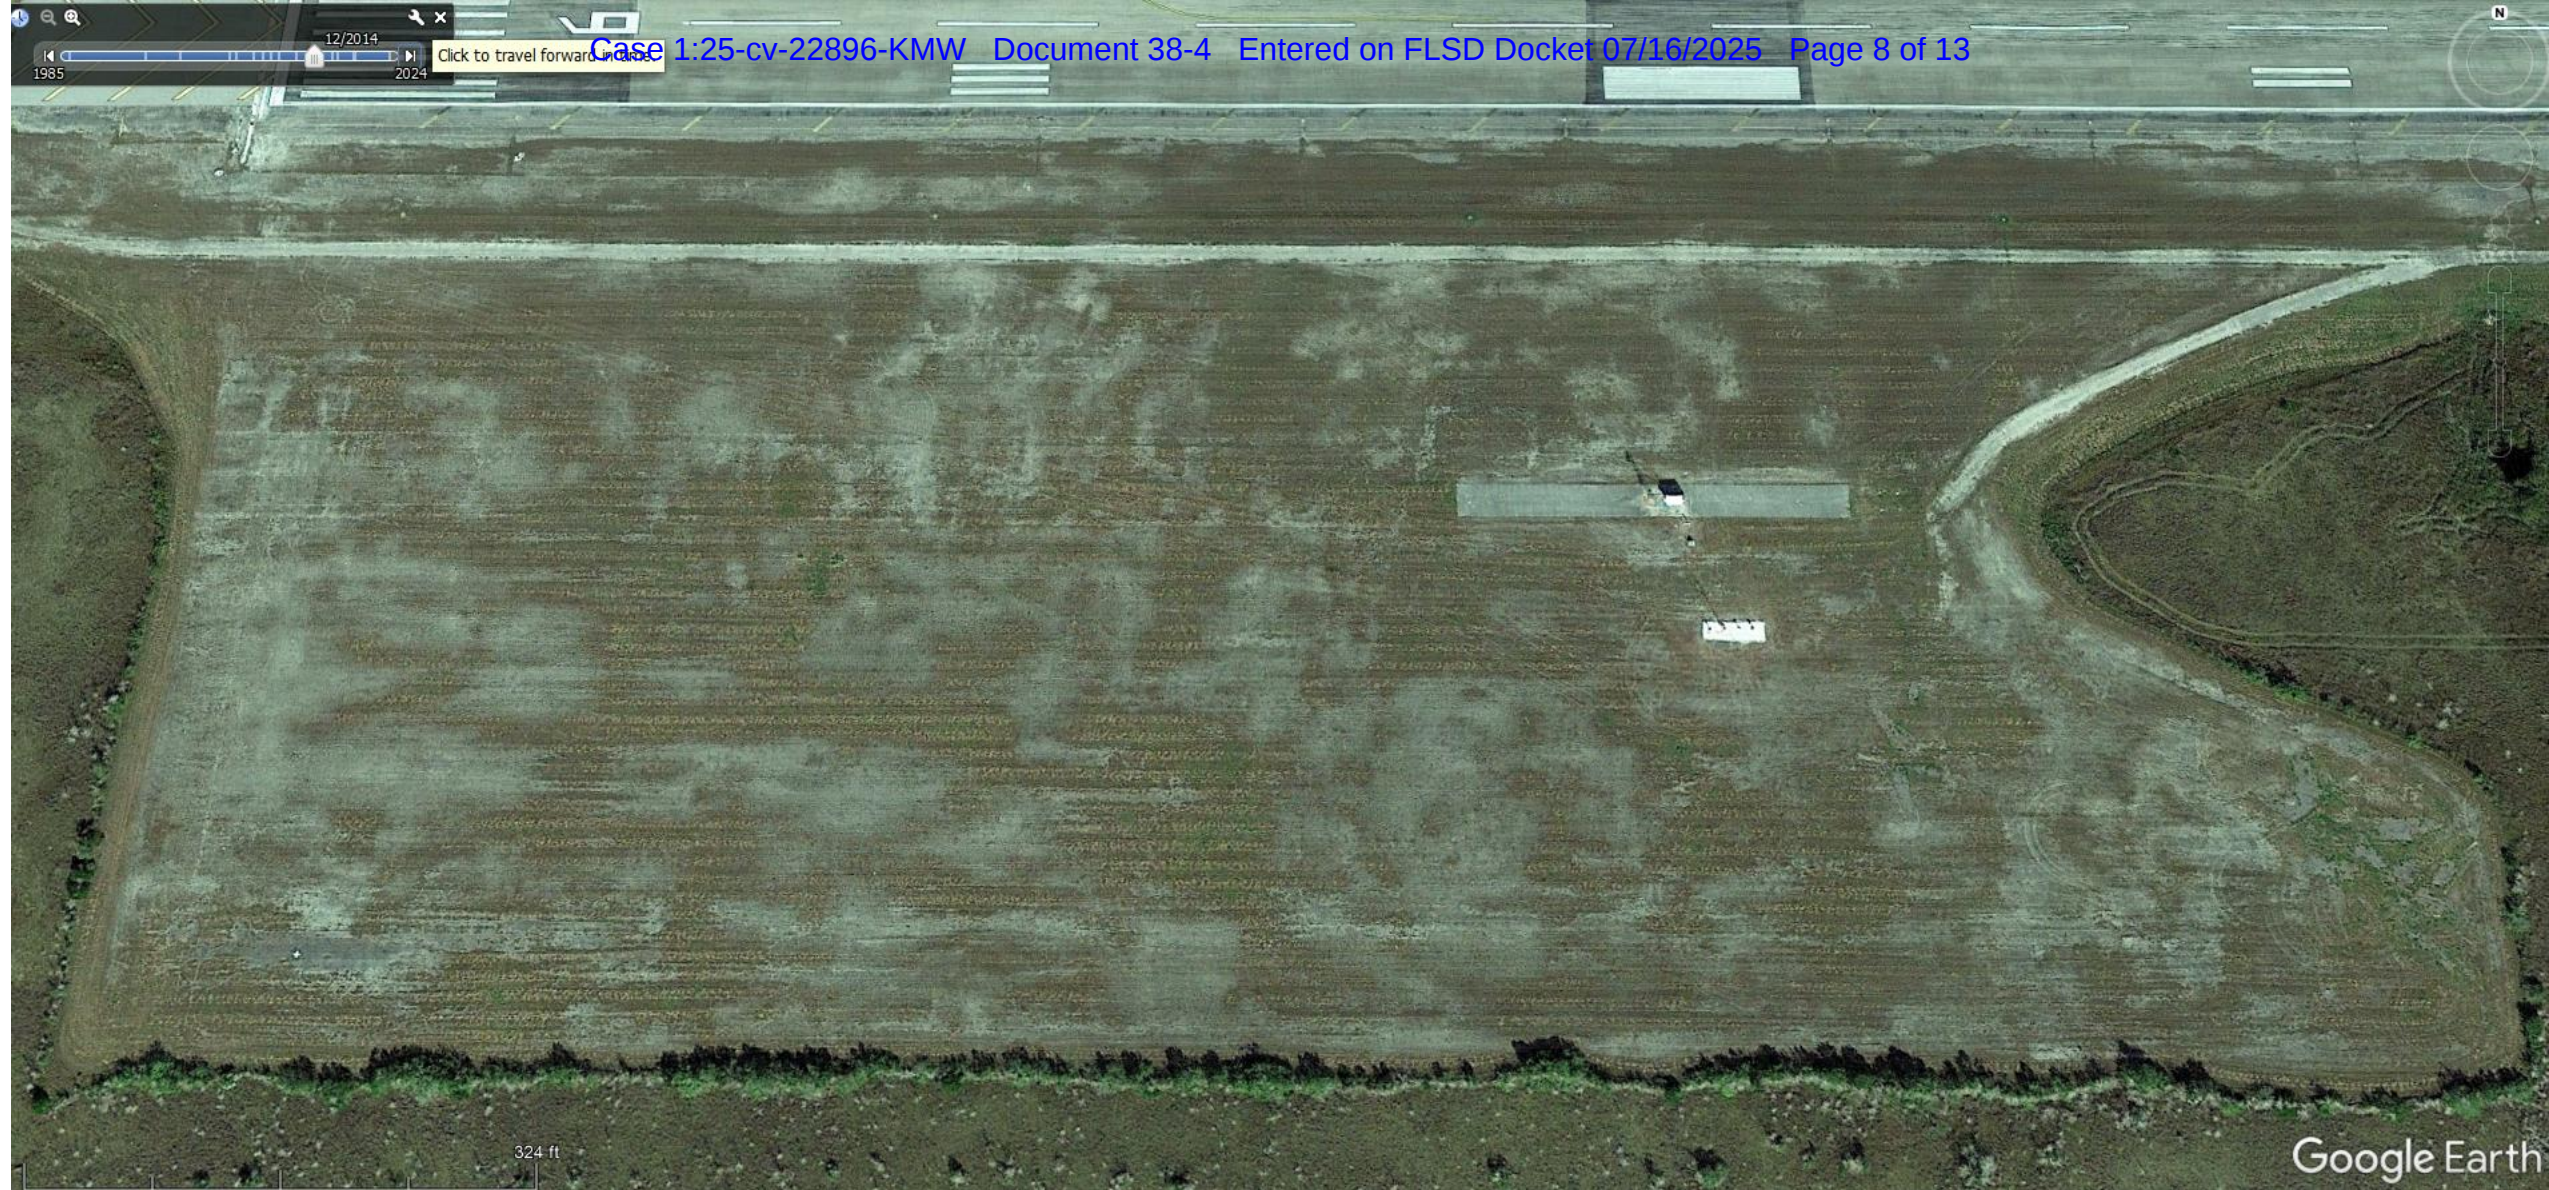
Google Earth historical imagery, 2014. Note the E-W patterning, which is likely from mowing equipment. Vegetation that needed mowing would not grow on top of cement.

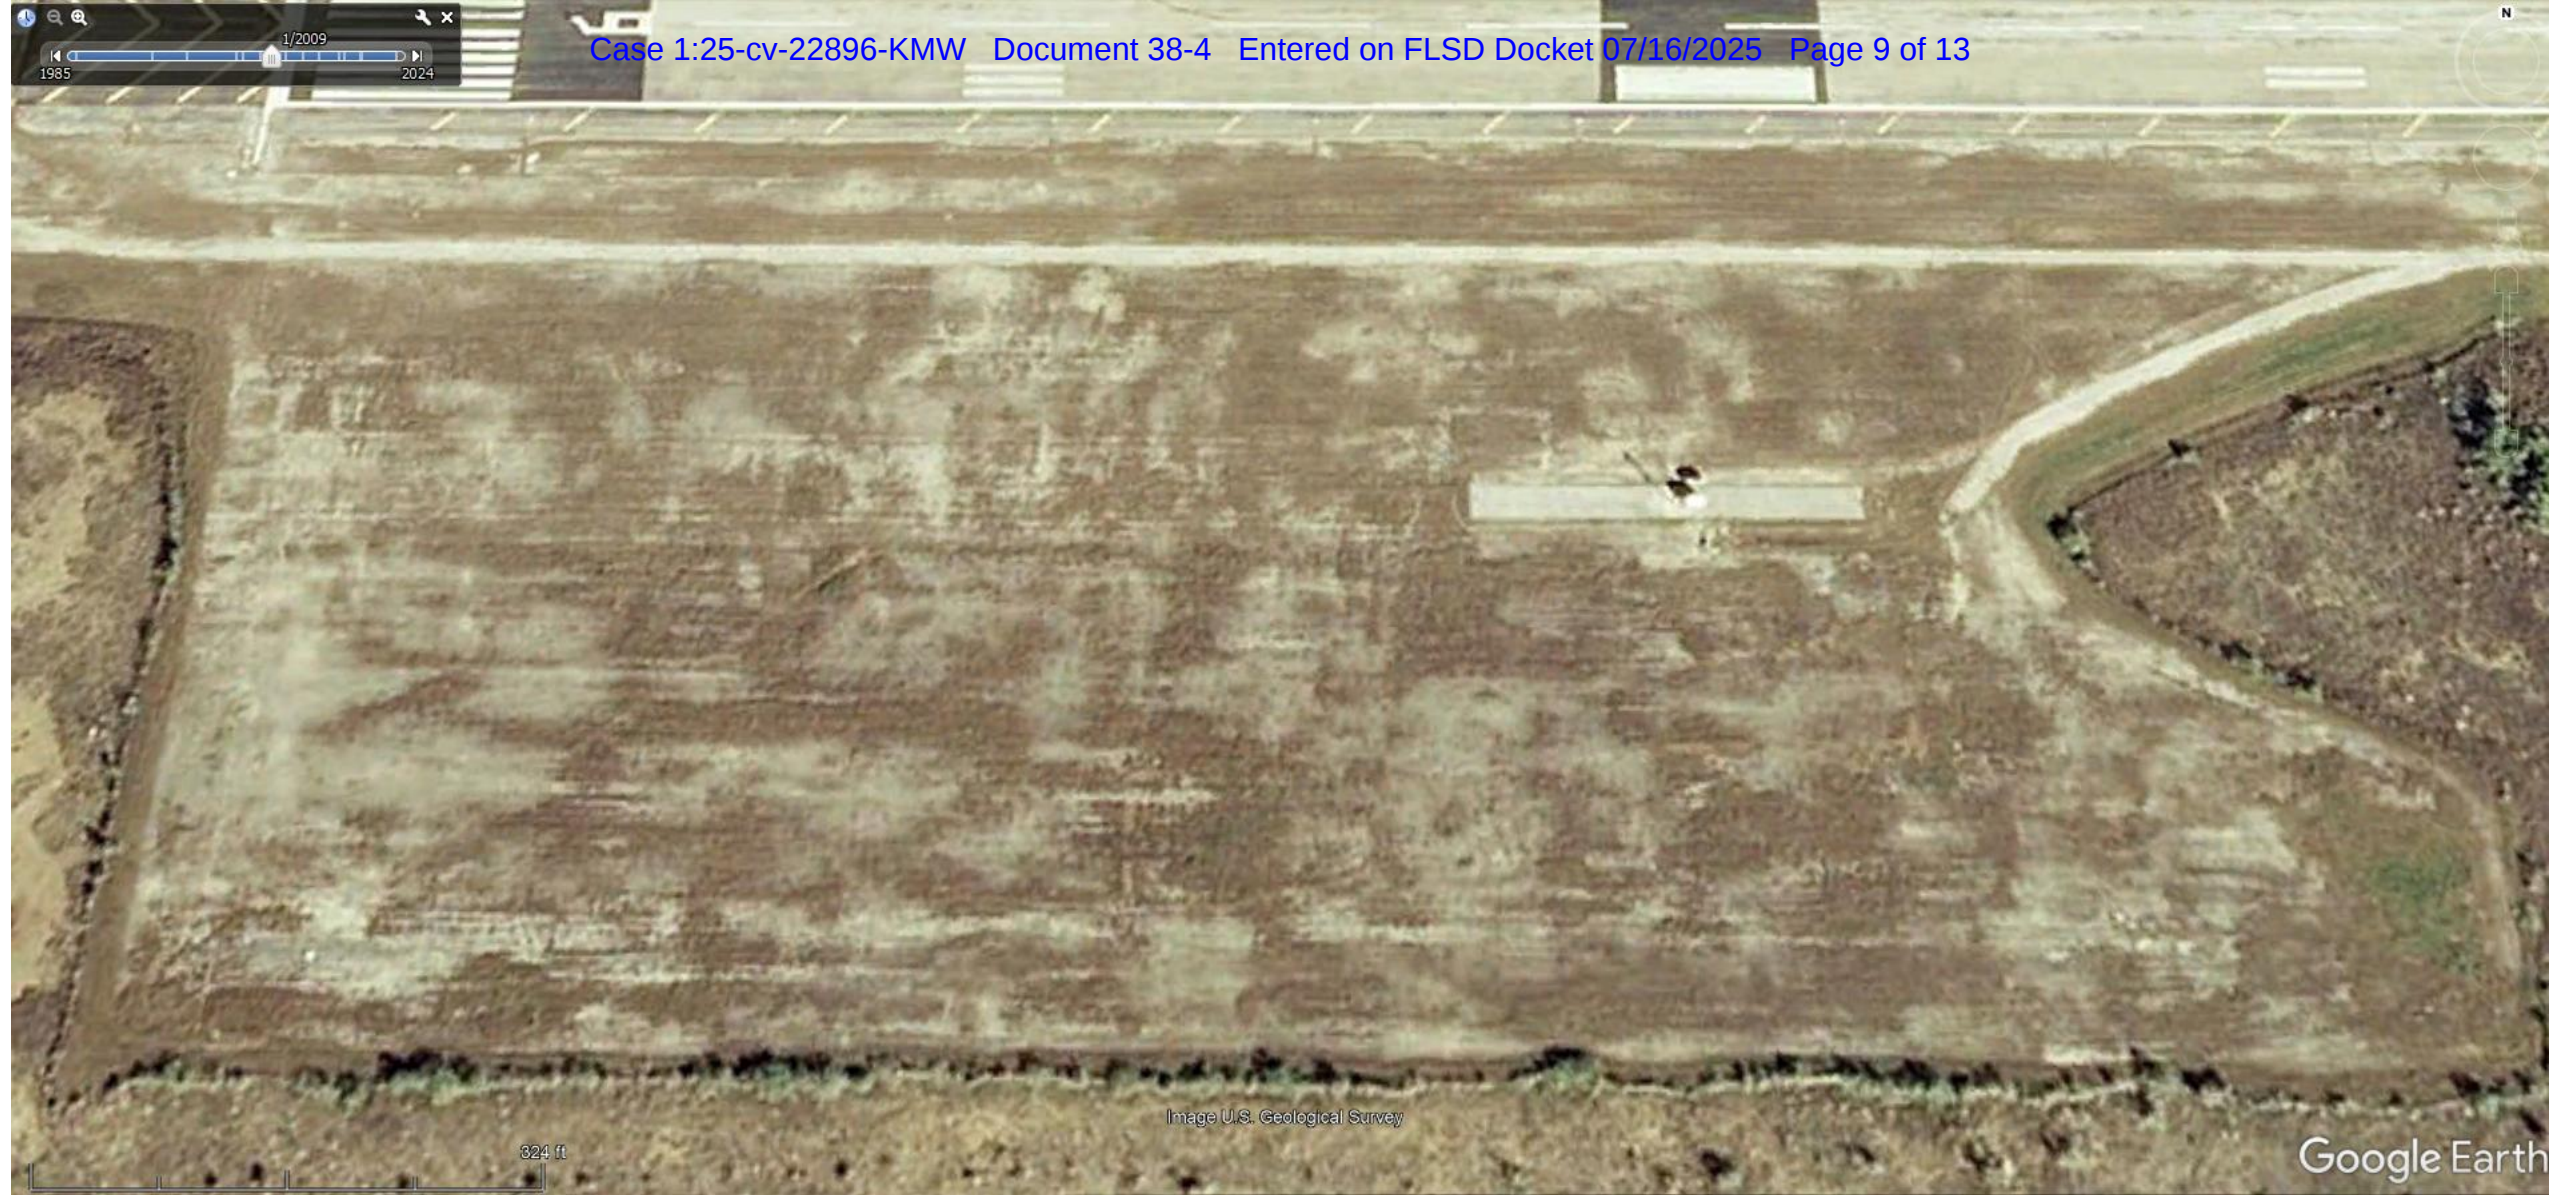
Google Earth historical imagery, 2009. Note the E-W patterning, which is likely from mowing equipment. Vegetation that needed mowing would not grow on top of cement.

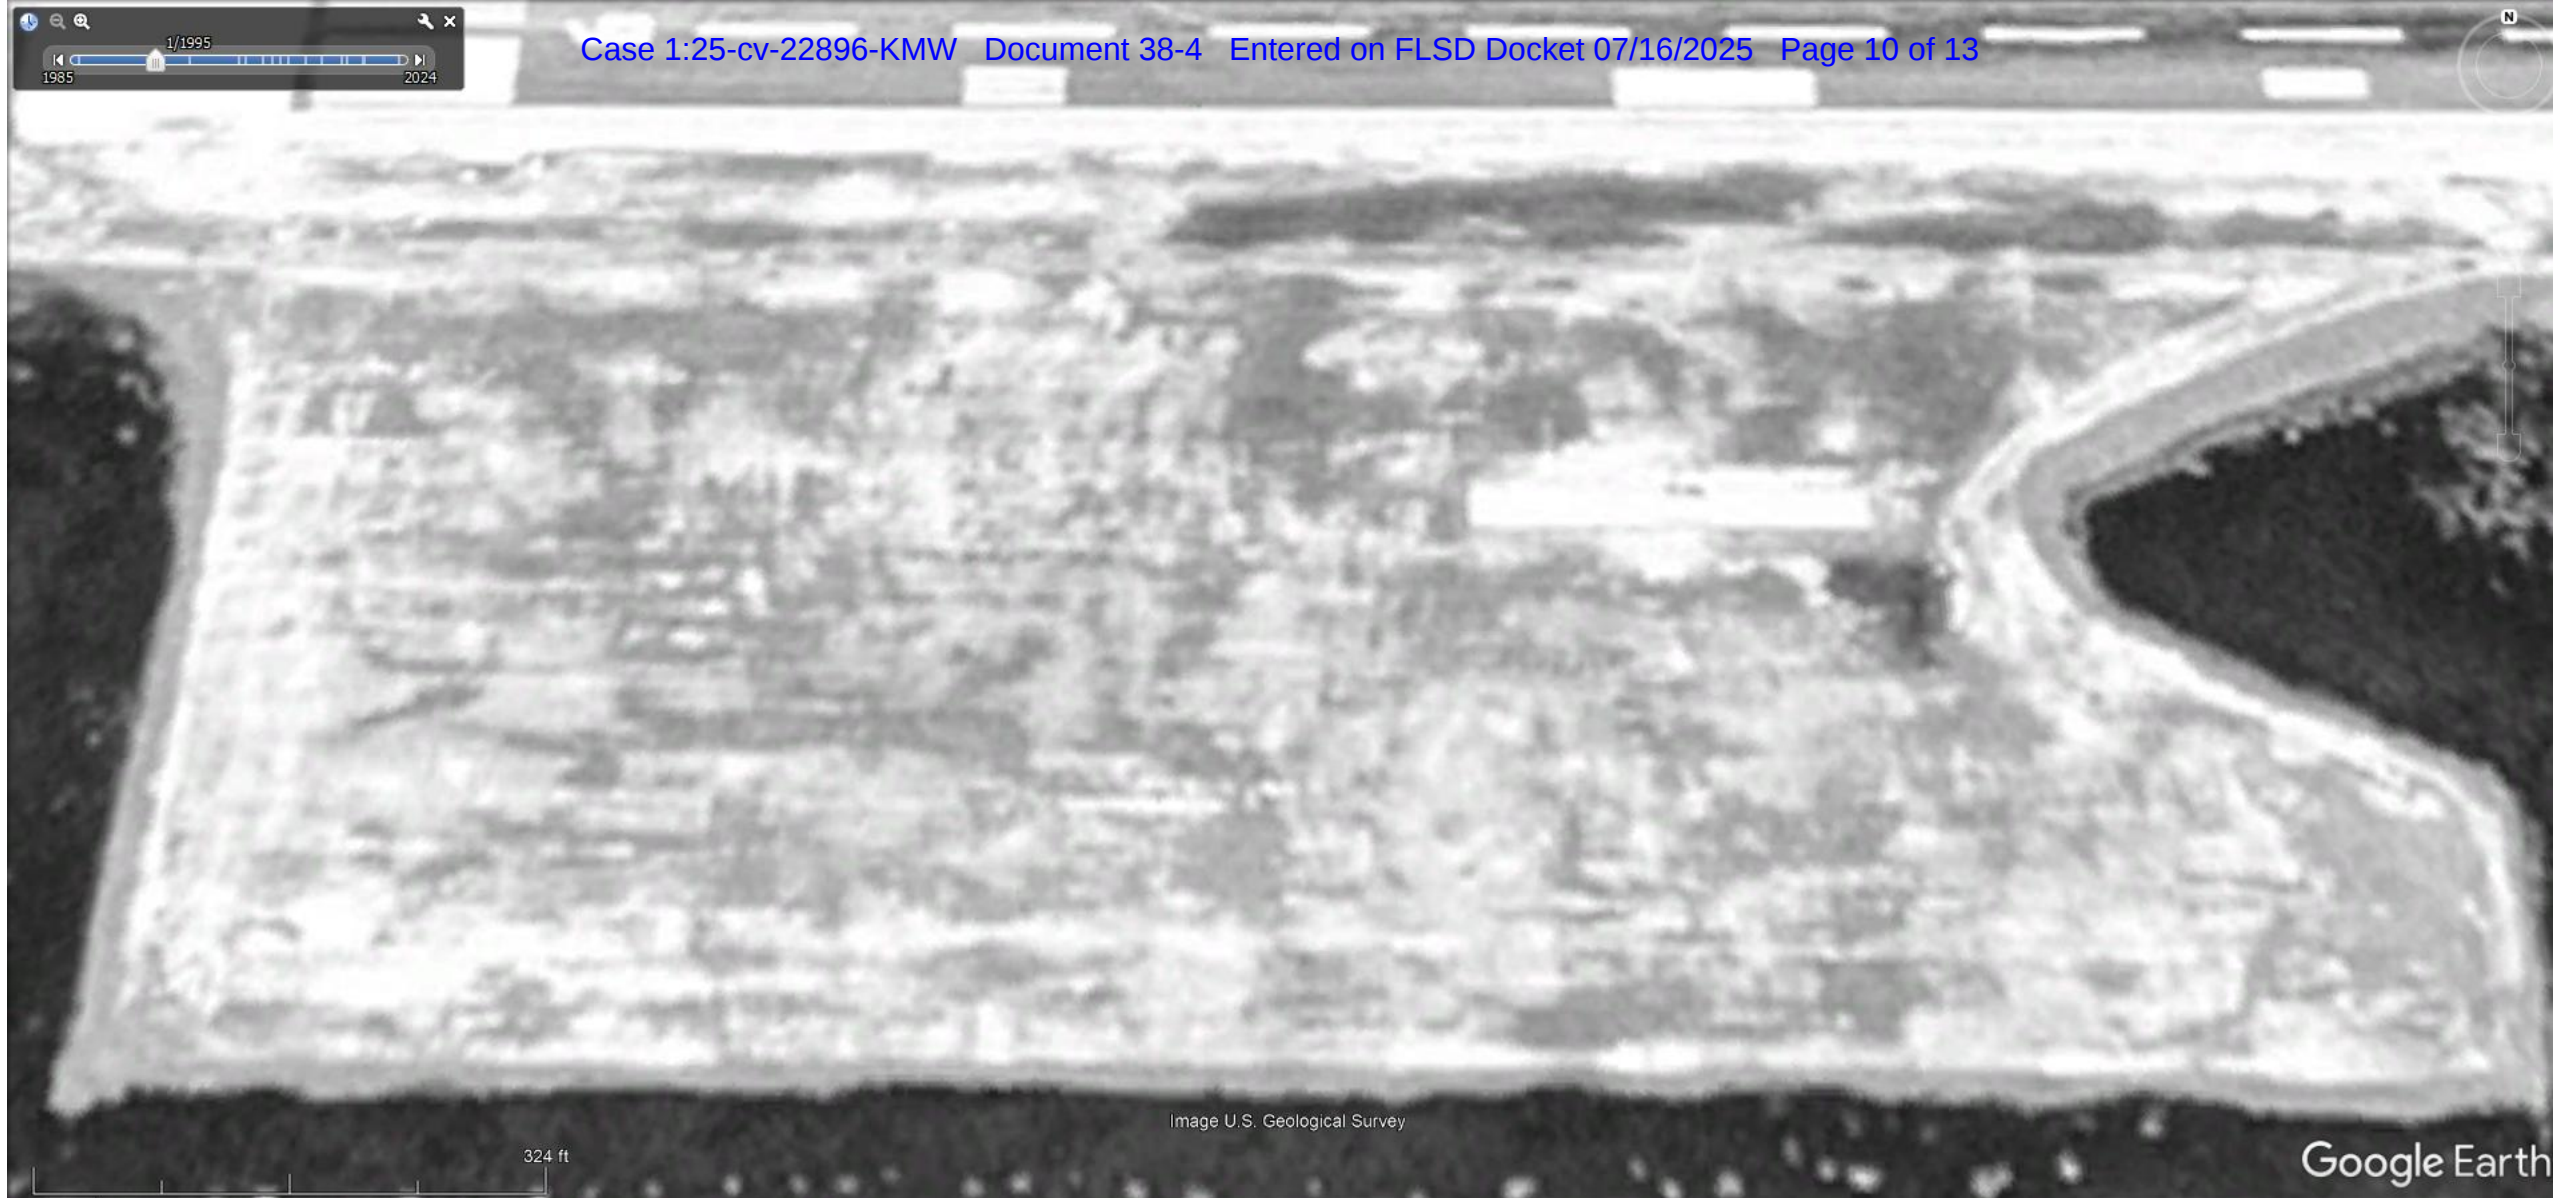
Google Earth historical imagery, 1995. Note the E-W patterning, which is likely from mowing equipment. Vegetation that needed mowing would not grow on top of cement.

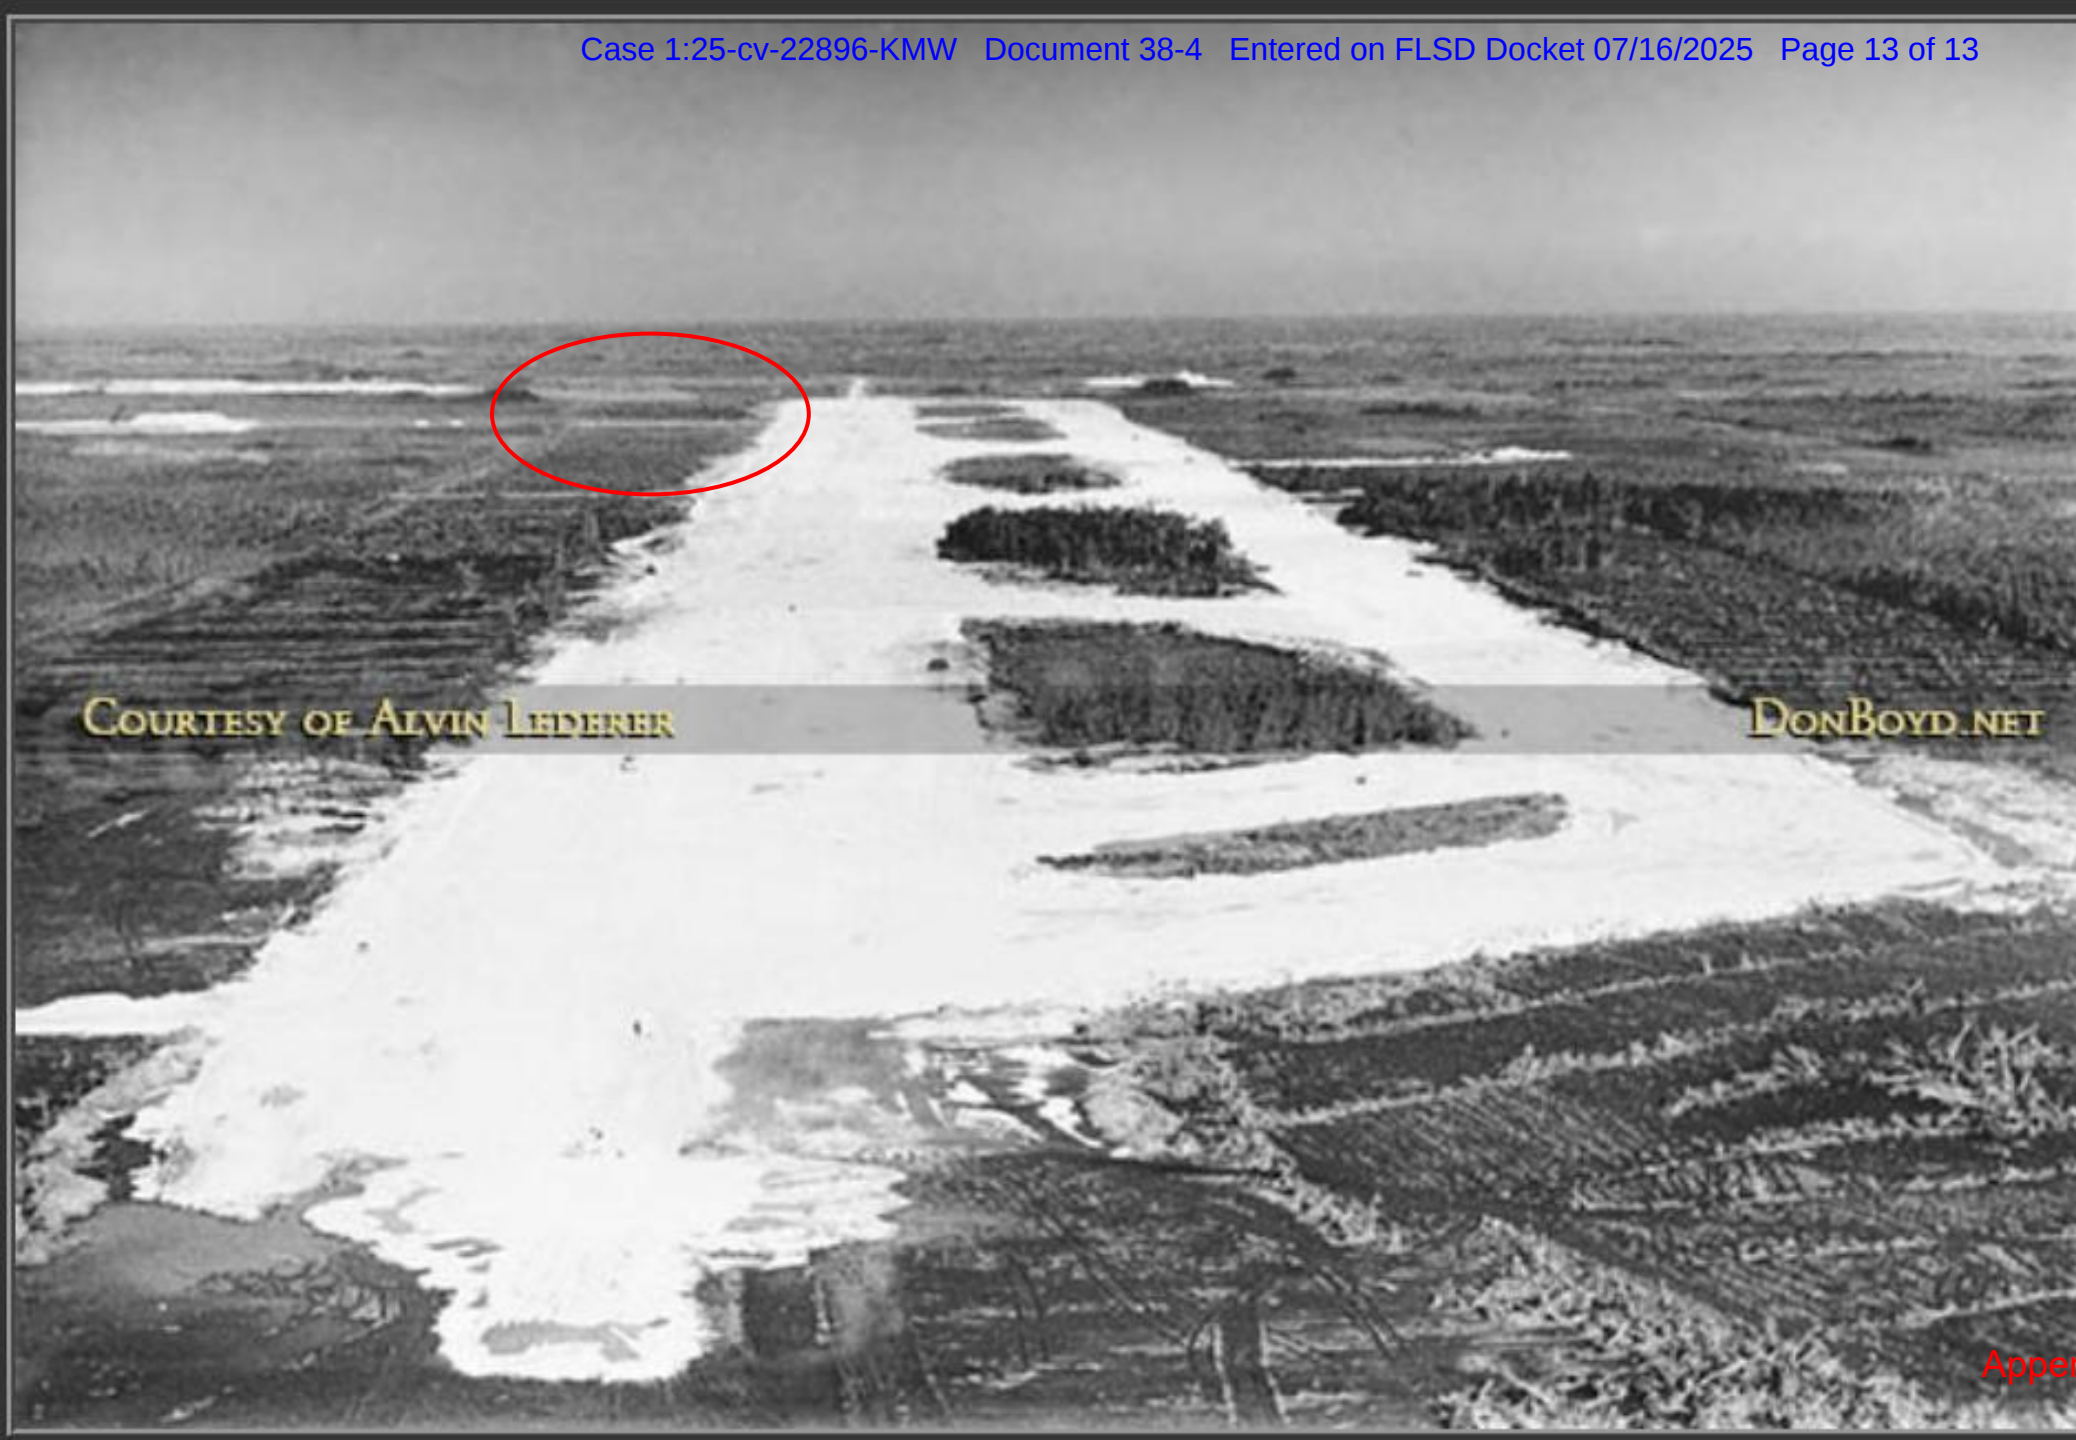
“1970 - aerial view of the Dade County Training & Transition Airport under construction.”

Red oval is area of new (2025) paving. It does not at all look covered with cement in 1970, the year construction was halted.
